A MV DIY ZNE DER by a GEEK, Part 1

Marc Rosenbaum, P.E. South Mountain Company West Tisbury, MA

Objective

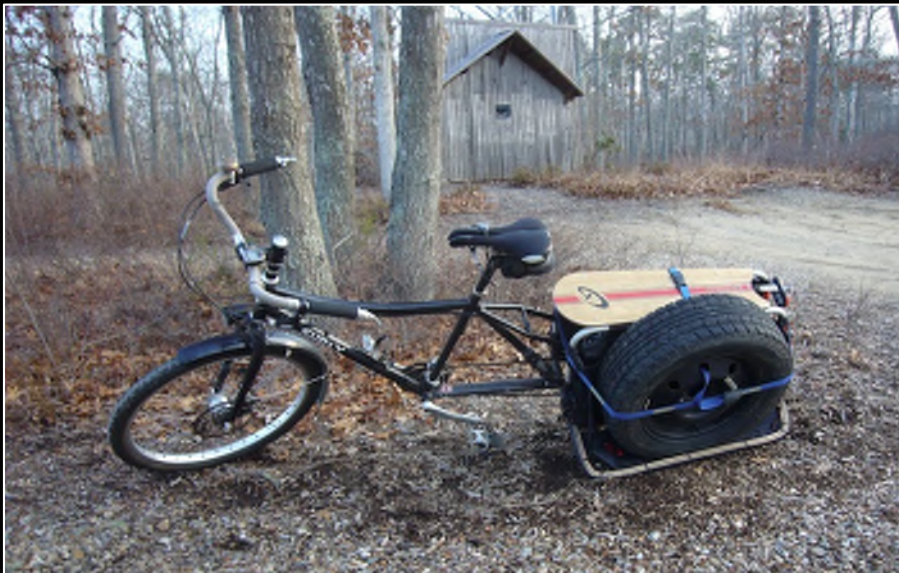
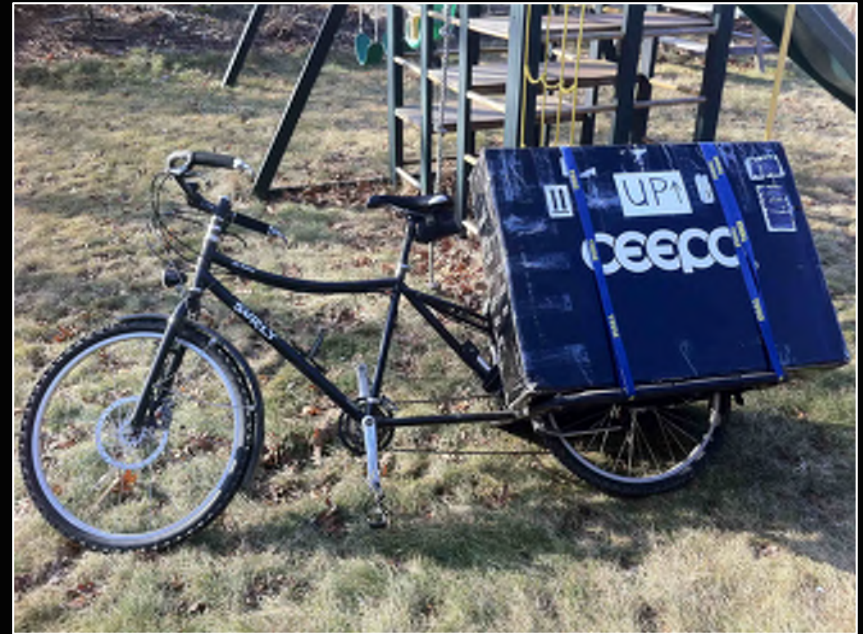
Cargo capacity
Generator lighting
Fenders
Studded tires

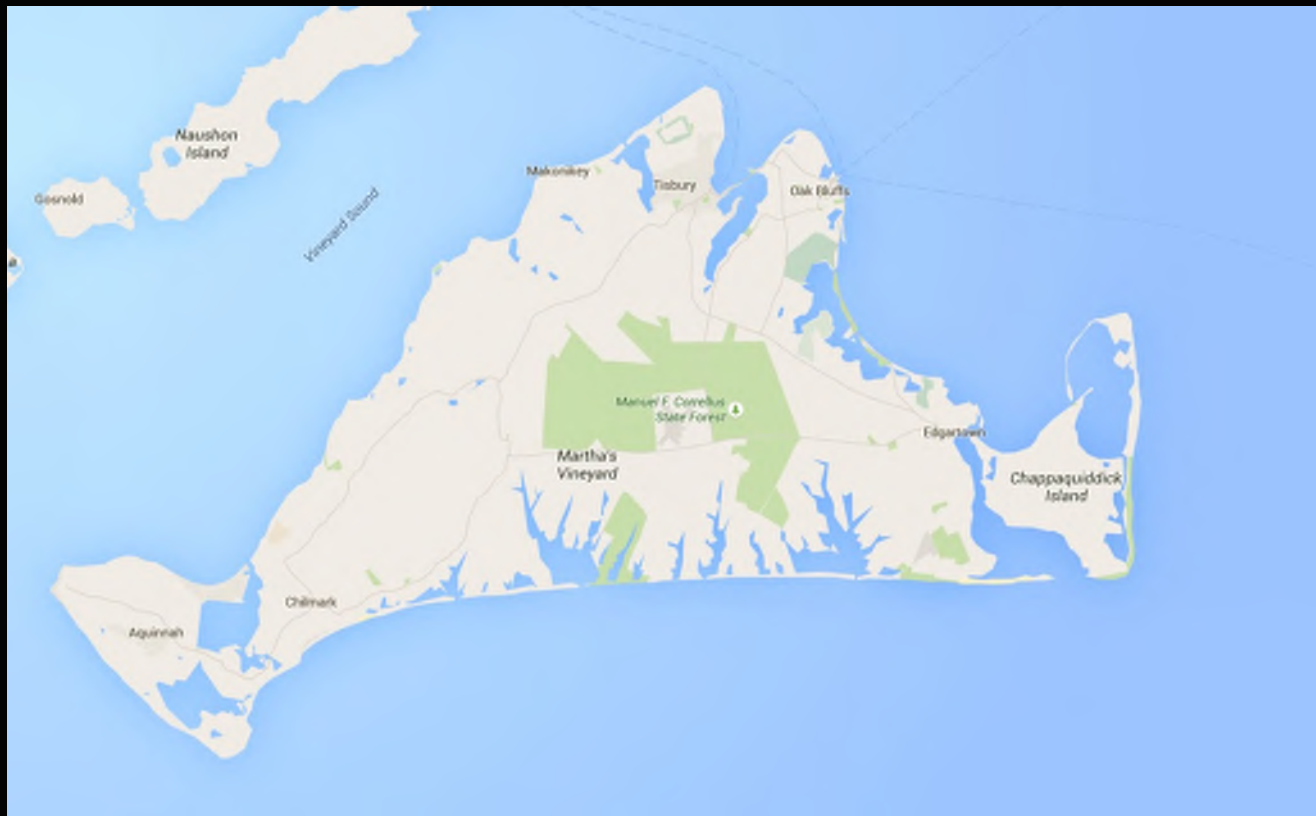
What We Started With

1,142 sf, 1 BR, 1 story, dry basement, 4 BR septic, good well, 200A and 100A underground services, 1-1/2A of sand plain, two funky outbuildings (converted truck bodies) in the middle of Martha's Vineyard

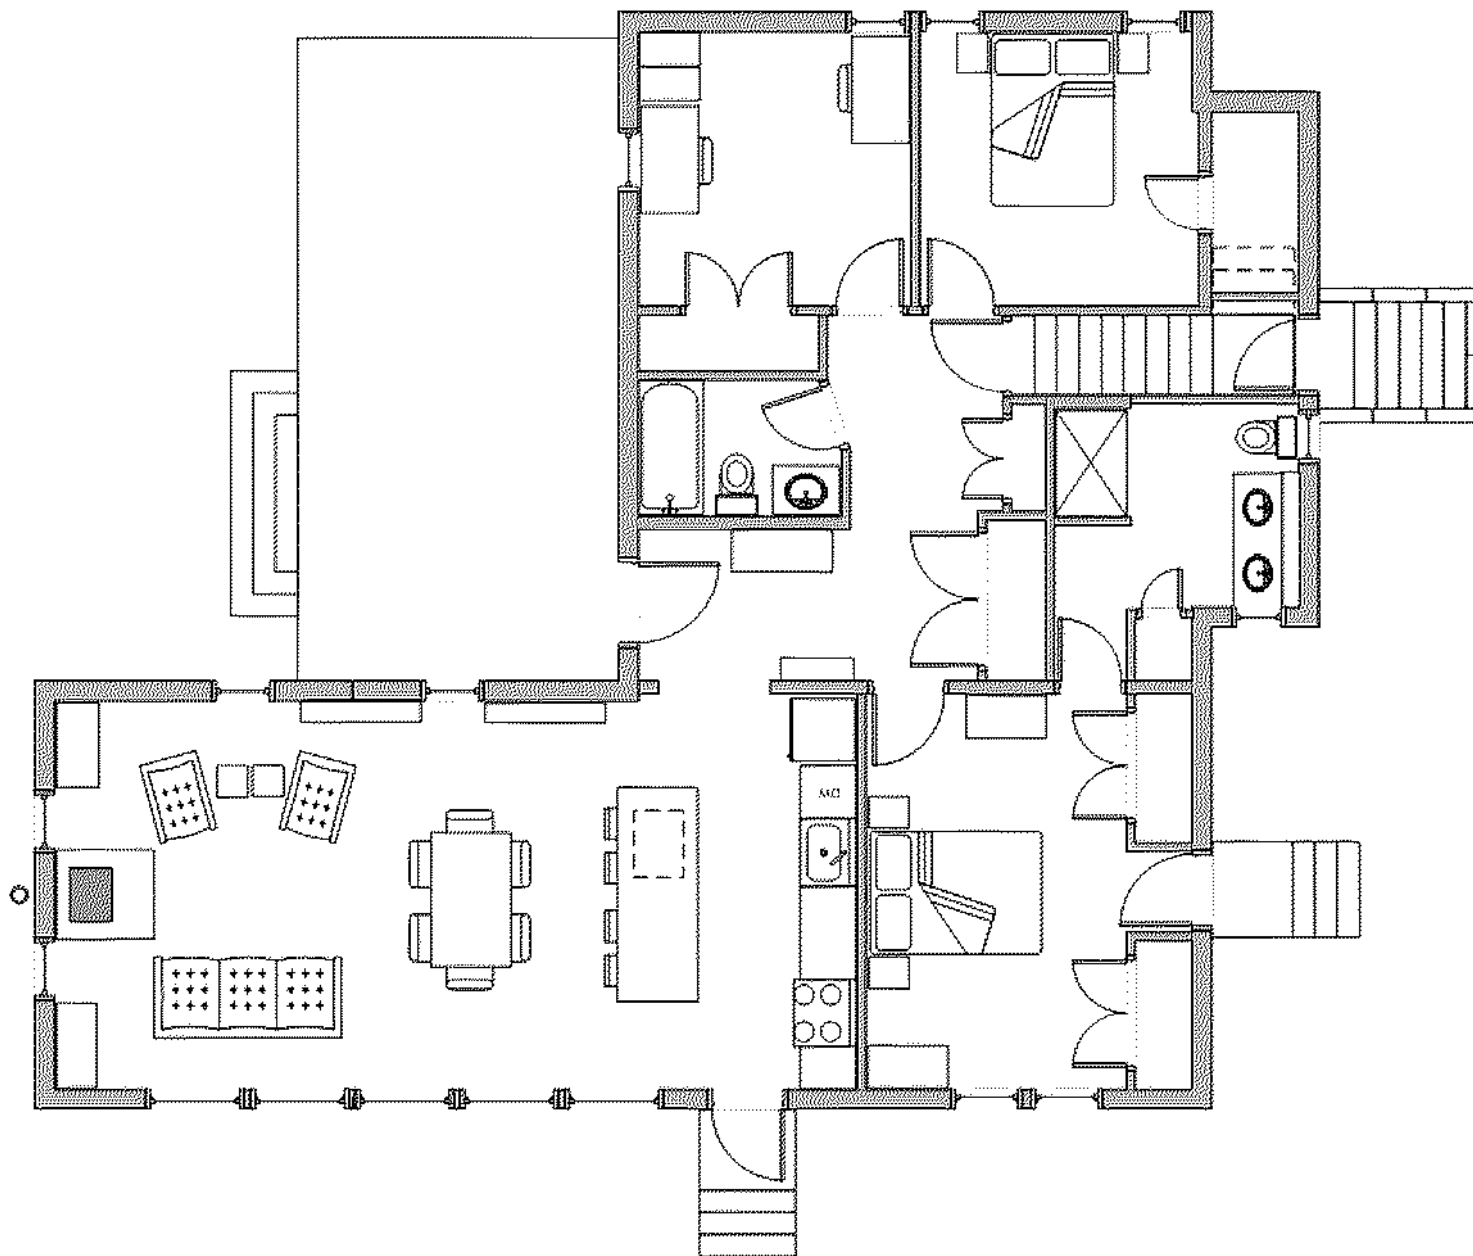
As-Built Design

- 3 BR, 2 baths
- Add S light, plus light on two sides
- Maintain high ceilings
- Southwestern feel
- Minimize added sf

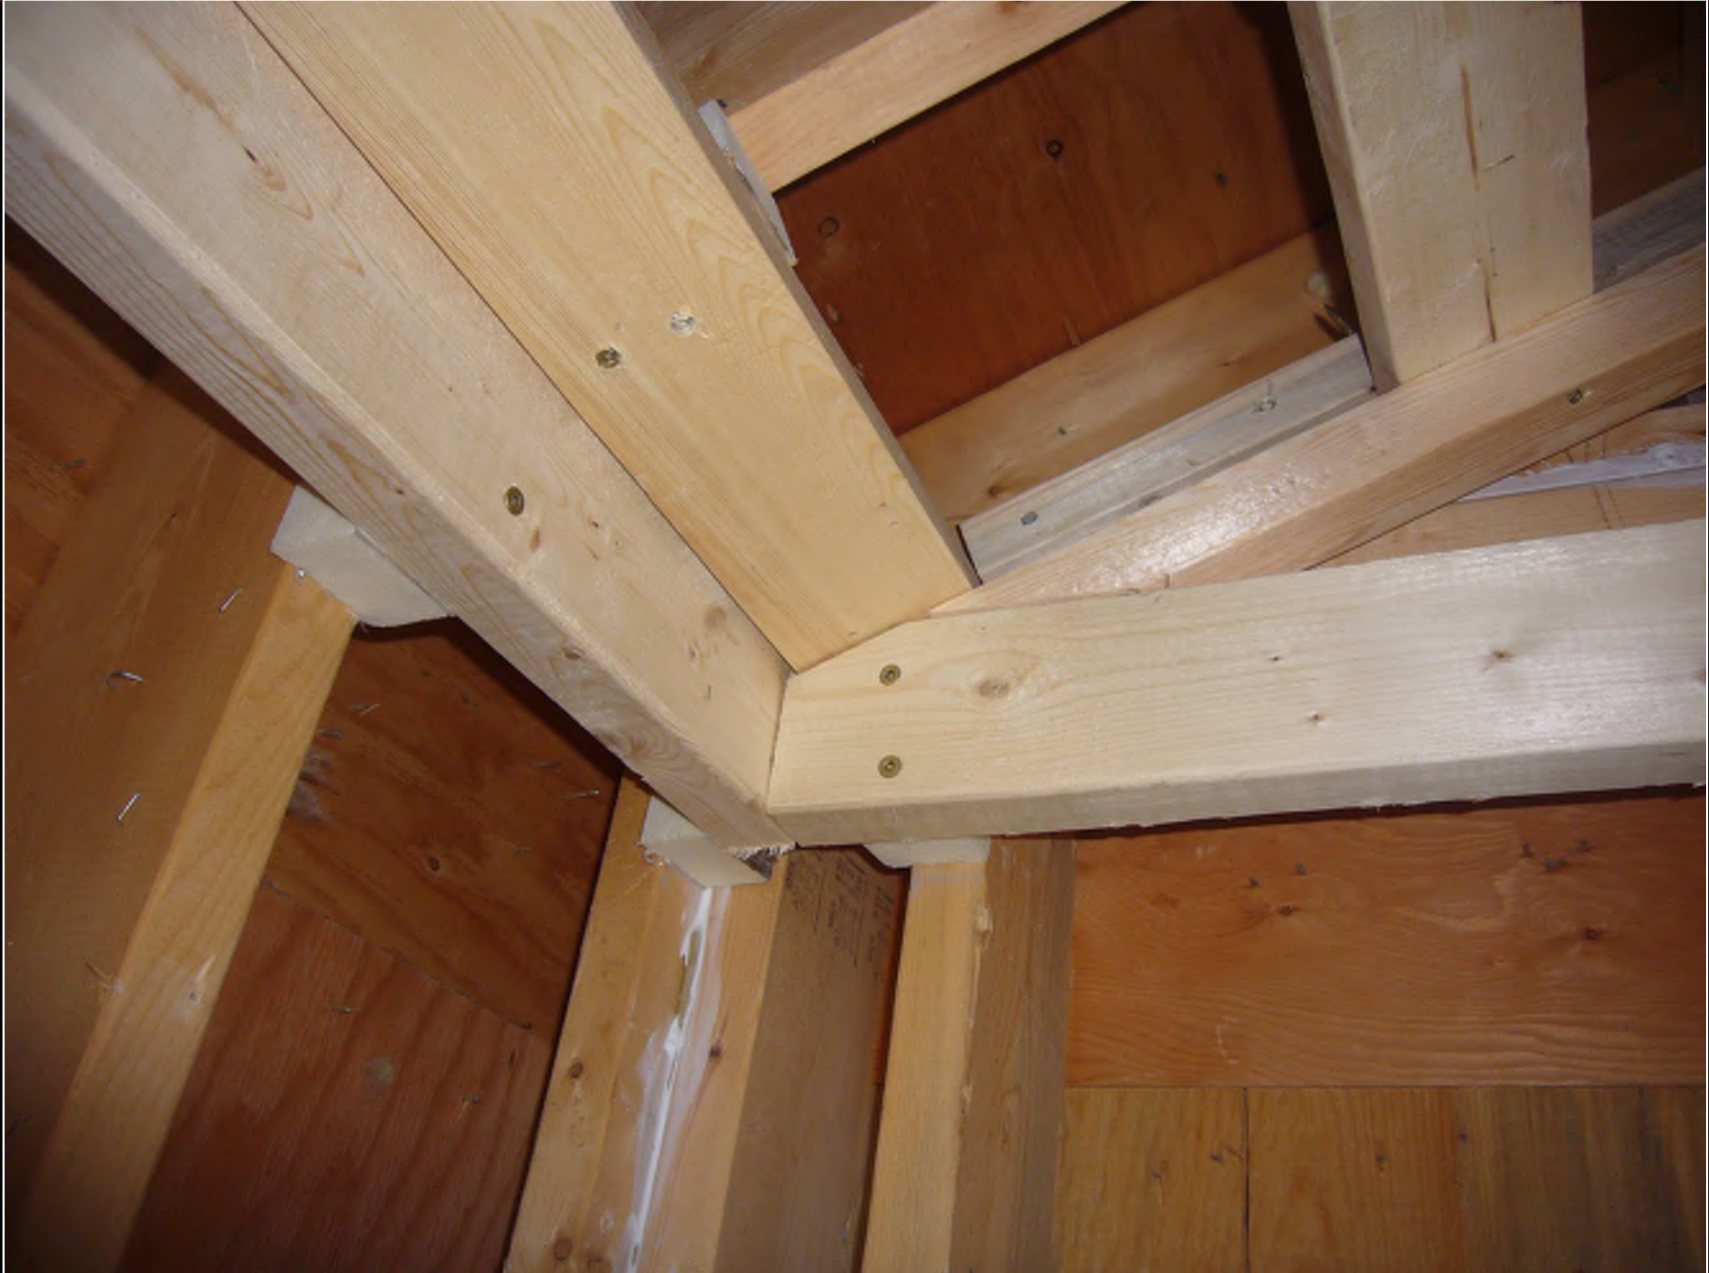
Foam + Strapping

- My original intention was to build inwards with two 1-1/2 inch layers of foil-faced polyisocyanurate foam over cavity fill in the existing 2x6 studs and 2x10 rafters
- Taping the foam would be the AB
- Got cold feet about this as the project progressed
- Compromise was a layered approach of first 3 inches of closed cell spray foam (CCSF), then the balance of open cell spray foam (OCSF)
- Used 1-1/2 inch polyiso blocks over the existing framing then 2x4 flatwise strapping – 8-1/2 inch wall cavity, 12-1/4 inch roof cavity – with thermal bridging about R-32 / R-44
- Don't try this at home...
- AB was caulked wood to wood joints, and the CCSF

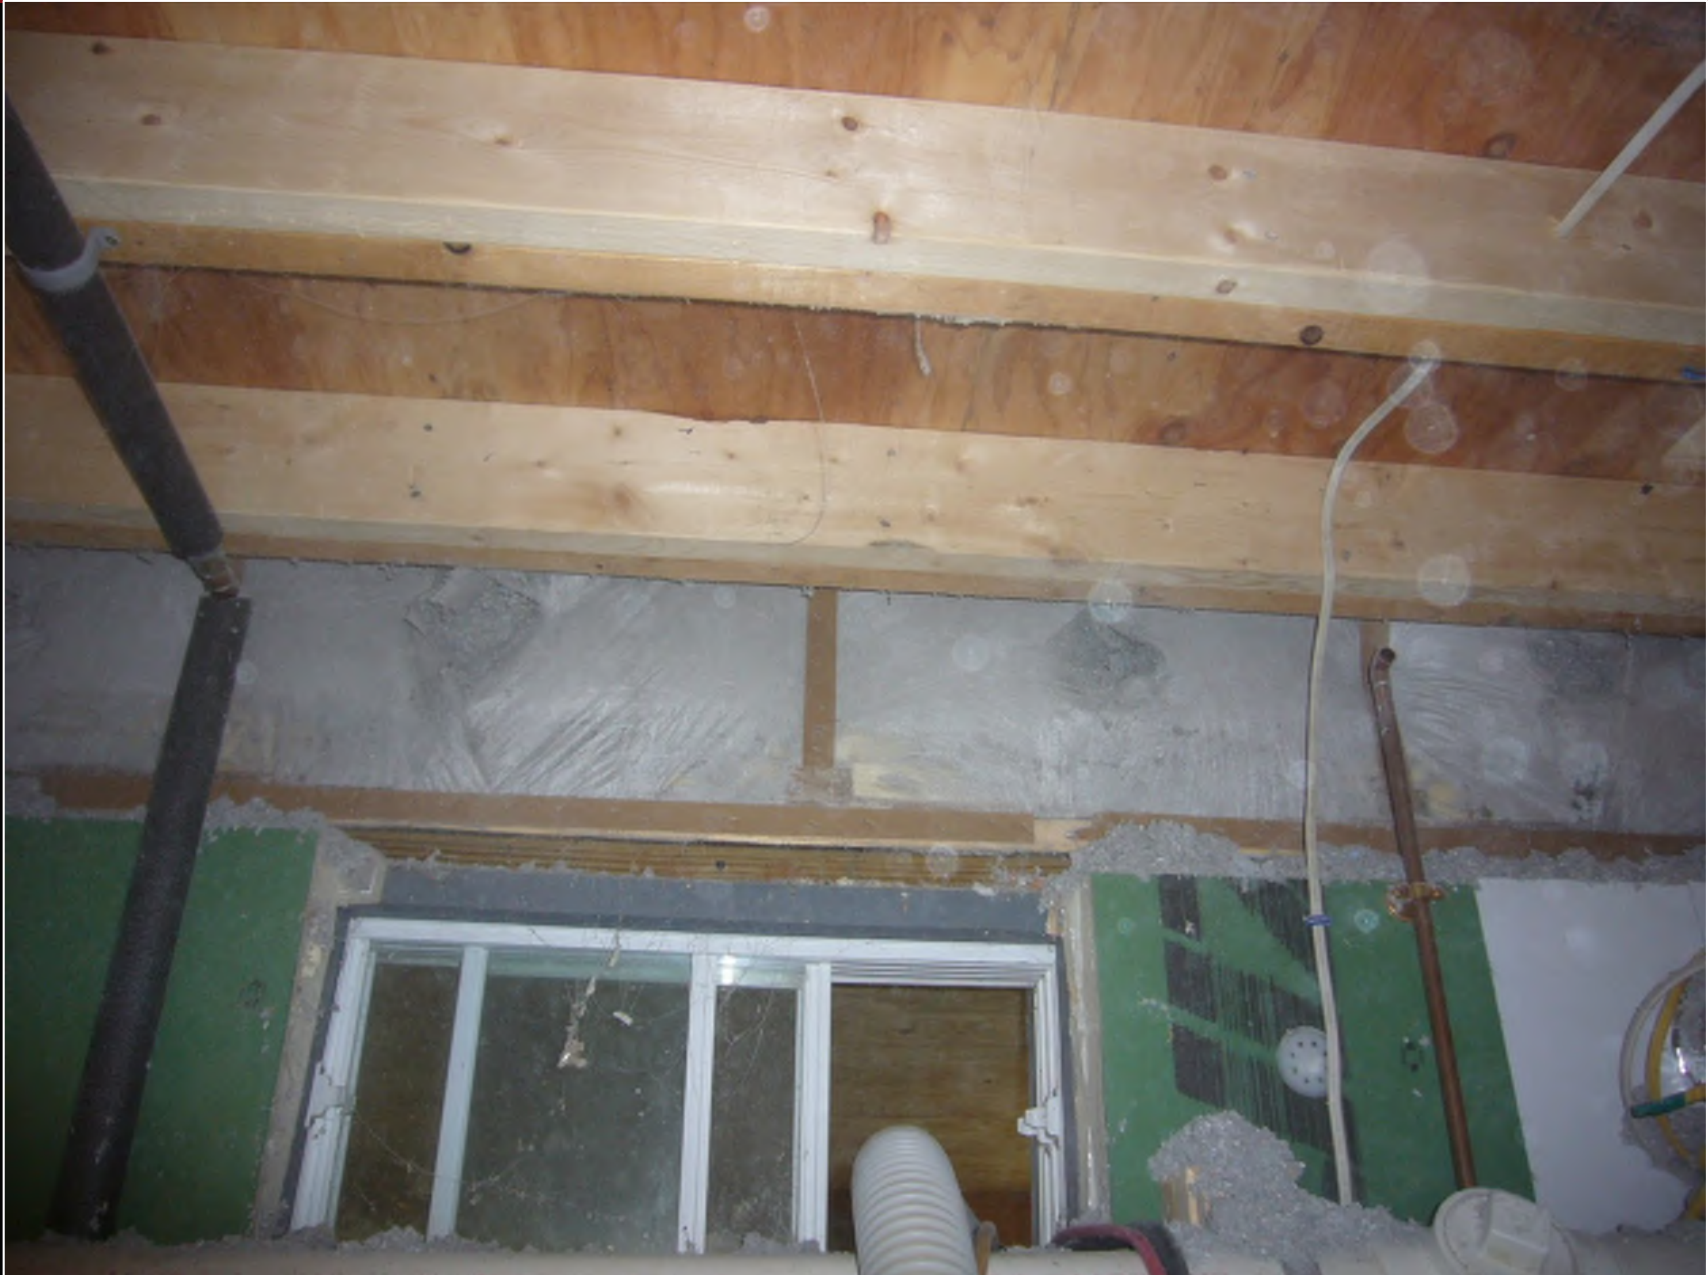
Cellulose Dense-packed From Basement

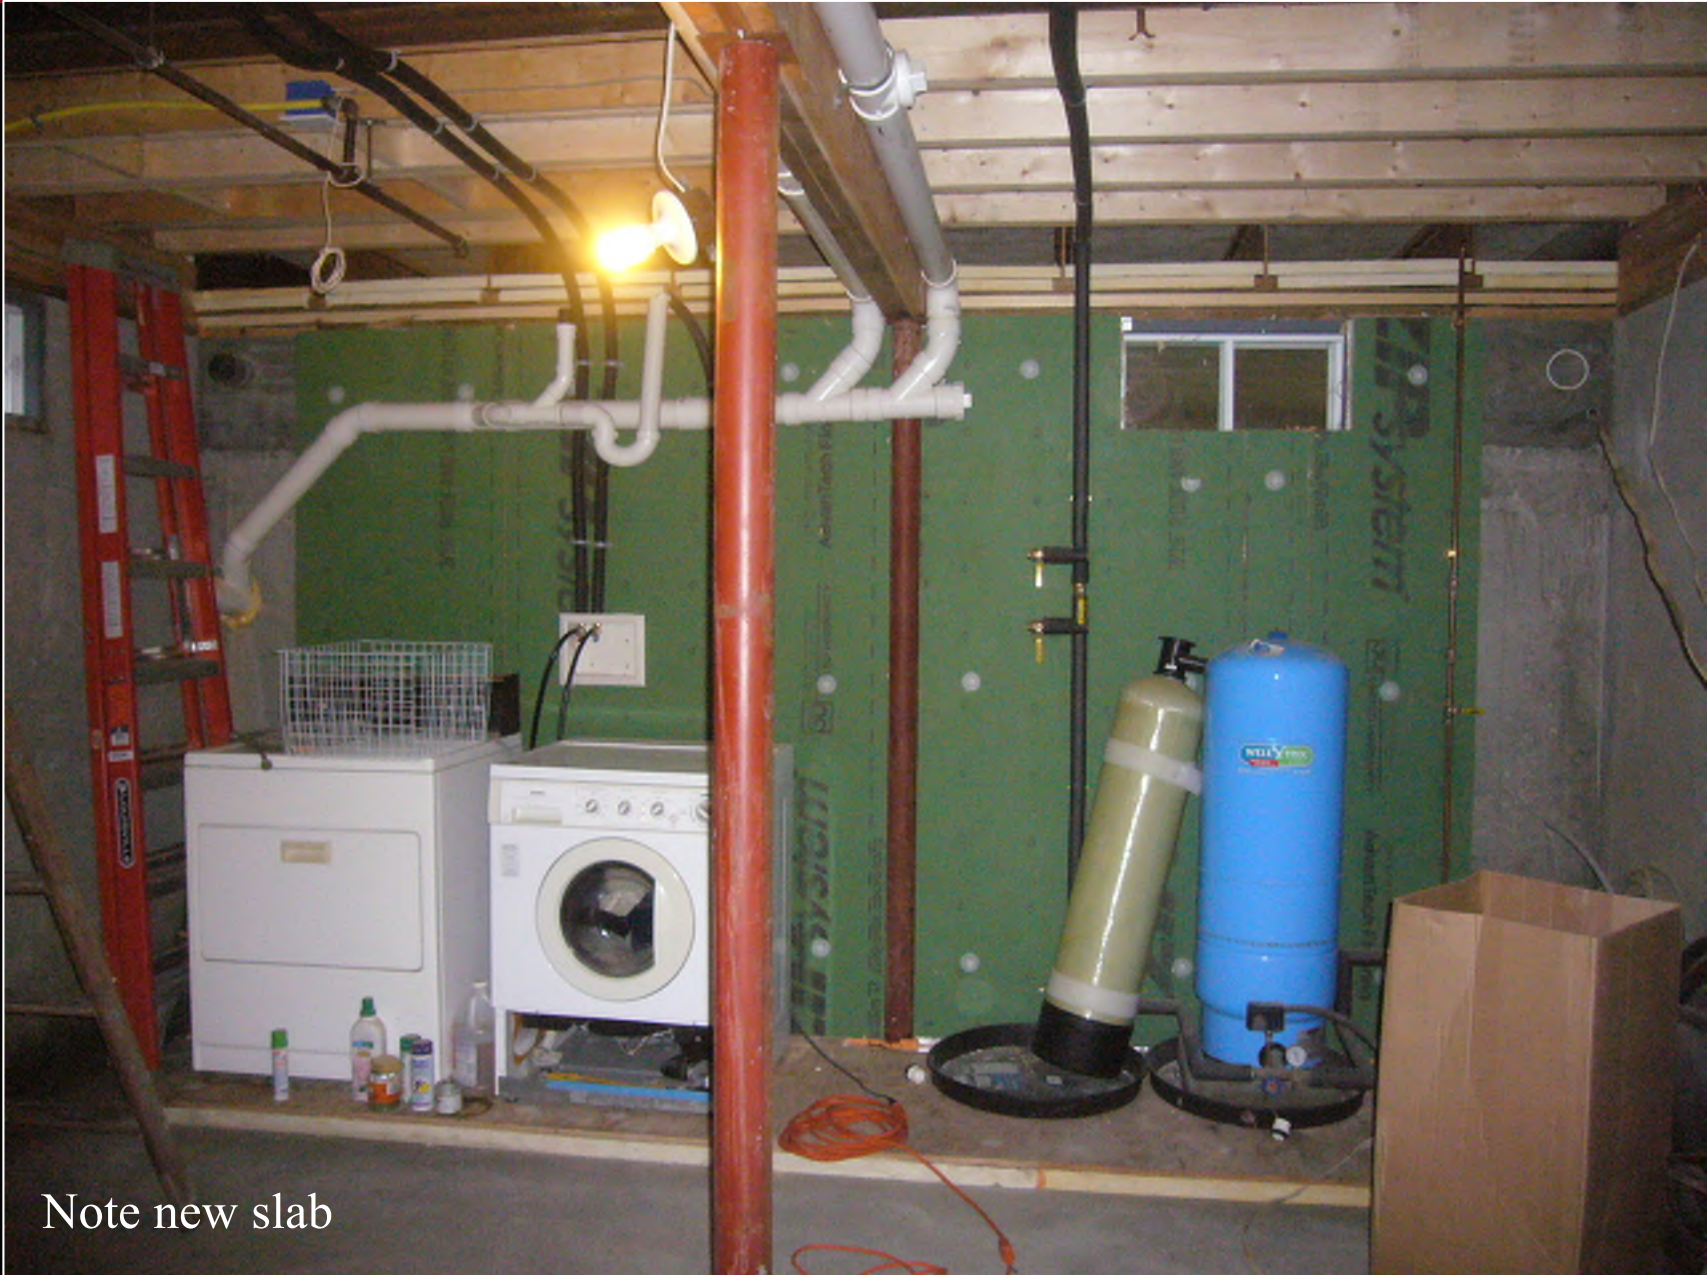
Prep For Wall + Slab Foam

Note new slab

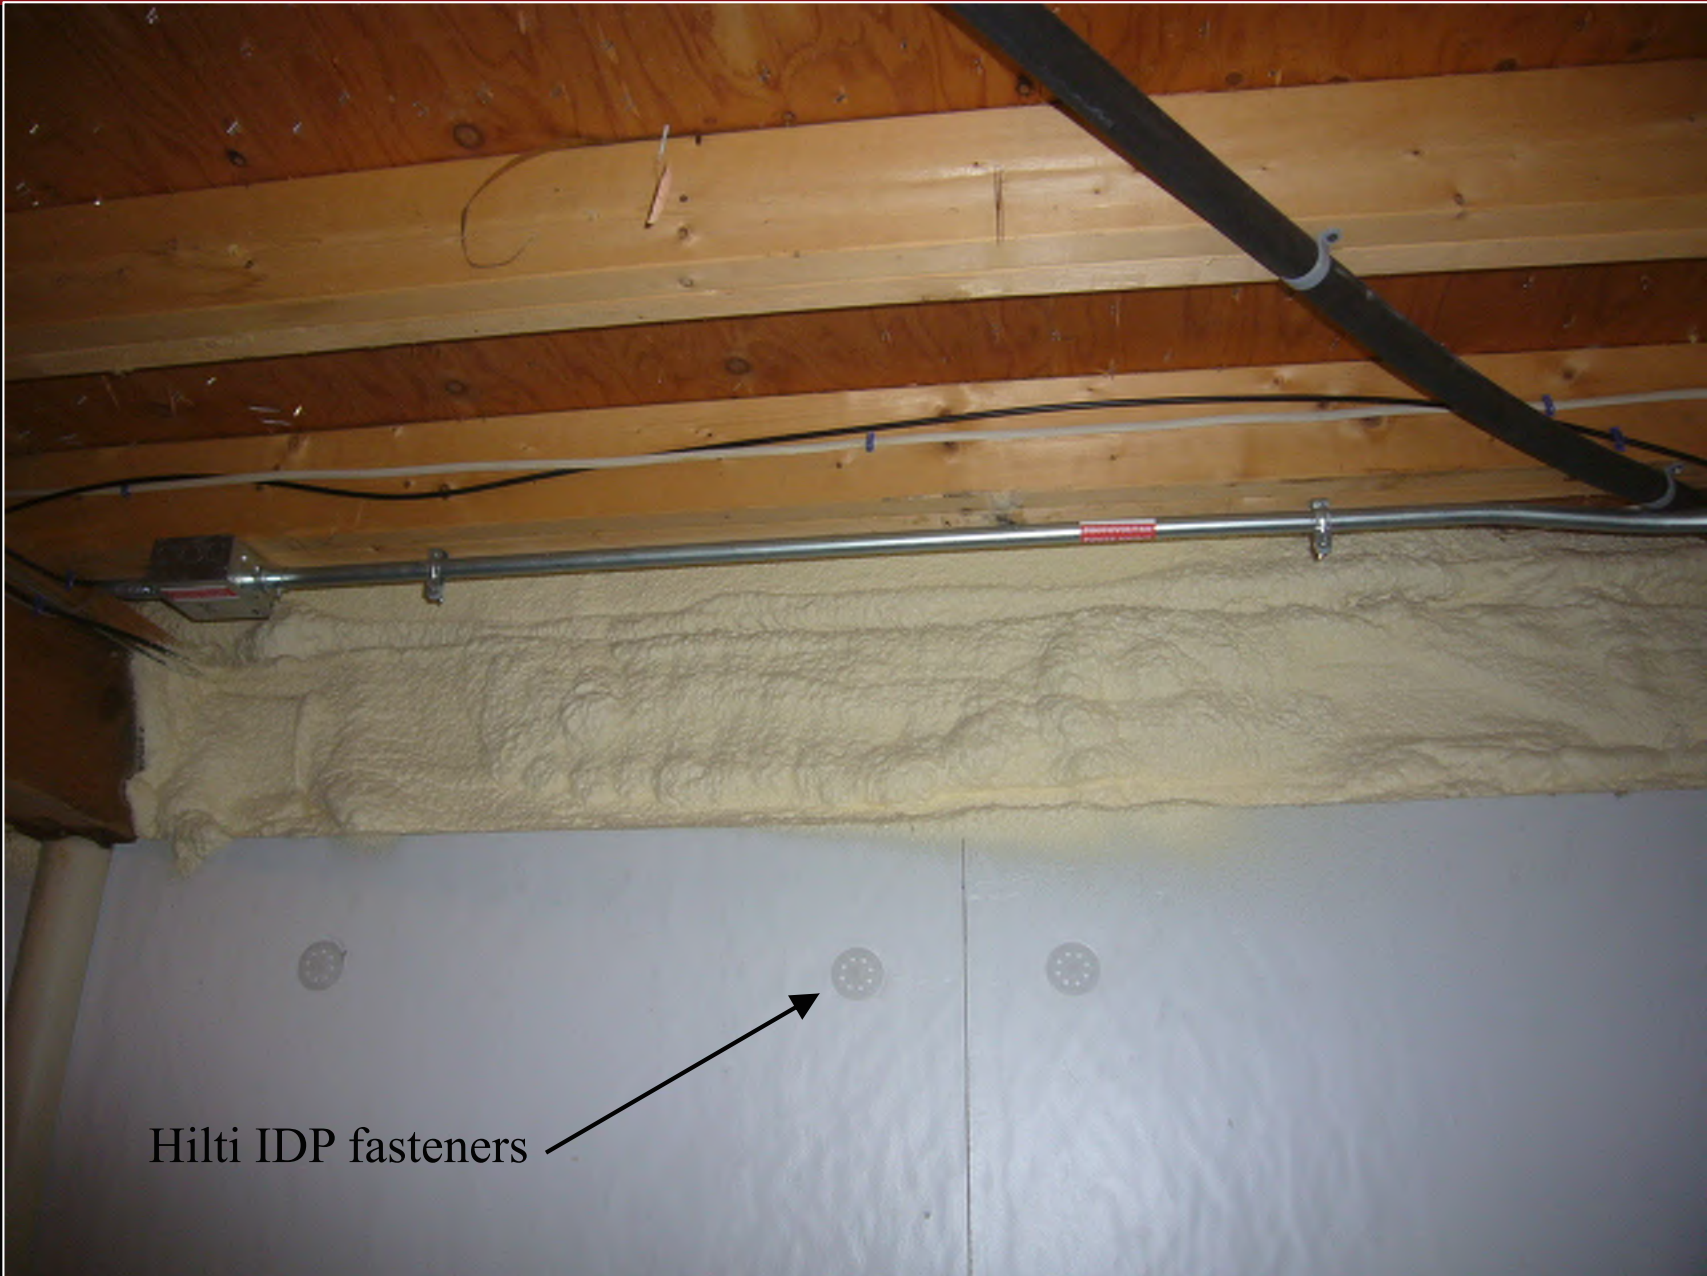
2" Polyiso, 1" Thermax, 3" CCSF

Hilti IDP fasteners

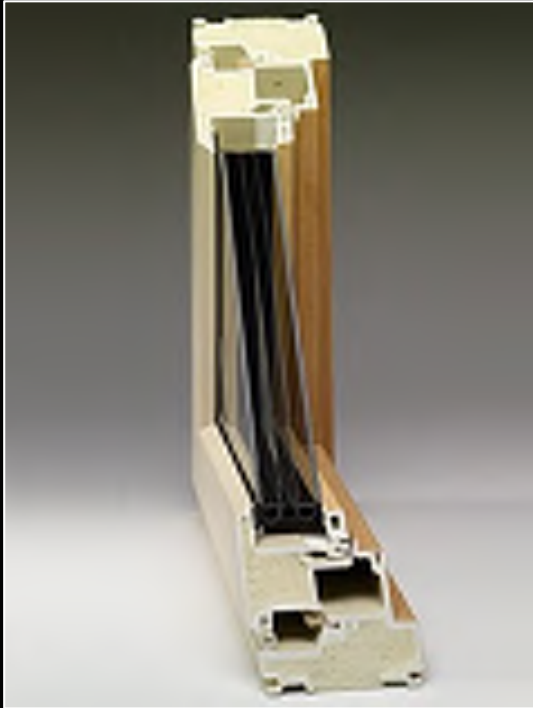
- Choose high SHGC over low U value
- Triple glazed, two Cardinal 180 low-e layers (3,5), argon fill
- Fixed south glazing – low iron outer lite, krypton fill
- Insulated fiberglass sash and frame
- Warm edge spacer

ENERGY PERFORMANCE RATINGS	
U-Factor (U.S. /I-P)	Solar Heat Gain Coefficient
0.16	0.51
ADDITIONAL PERFORMANCE RATINGS	
Visible Transmittance	Condensation Resistance
0.62	75

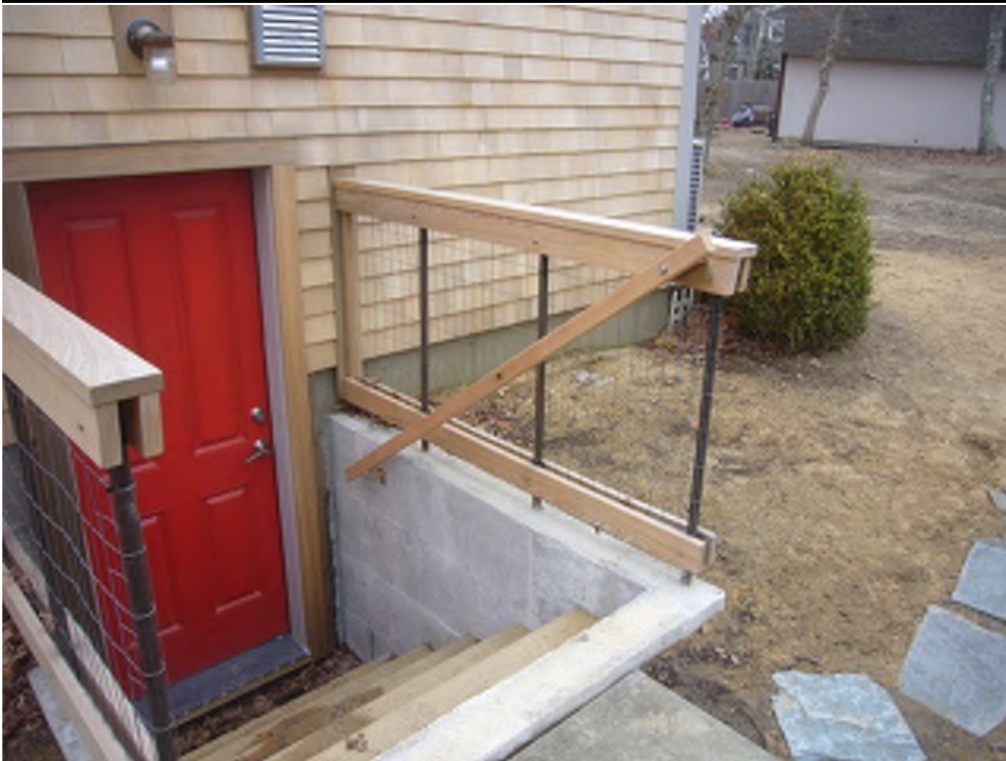
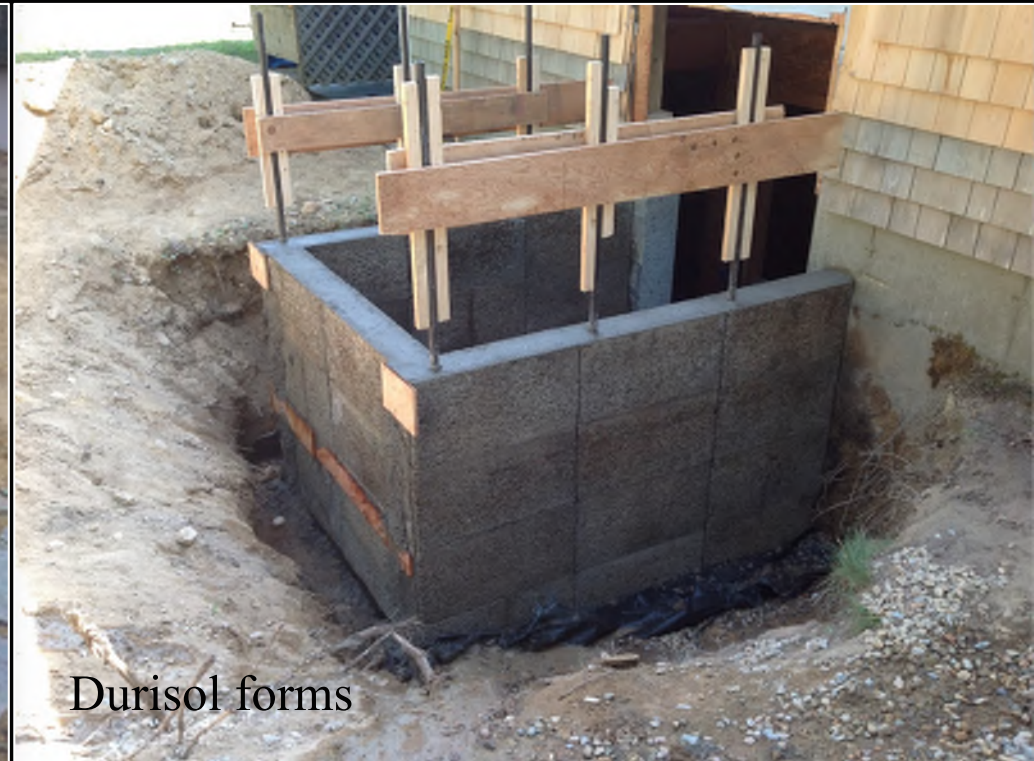
Exterior Doors

- Fiberglass skins, foam insulation
- Hardly any insulated triple glazed doors – big \$
- Four doors, one full lite, two half lite, one solid – 7% of total design heat loss
- Plan is to change out the glazing to triple

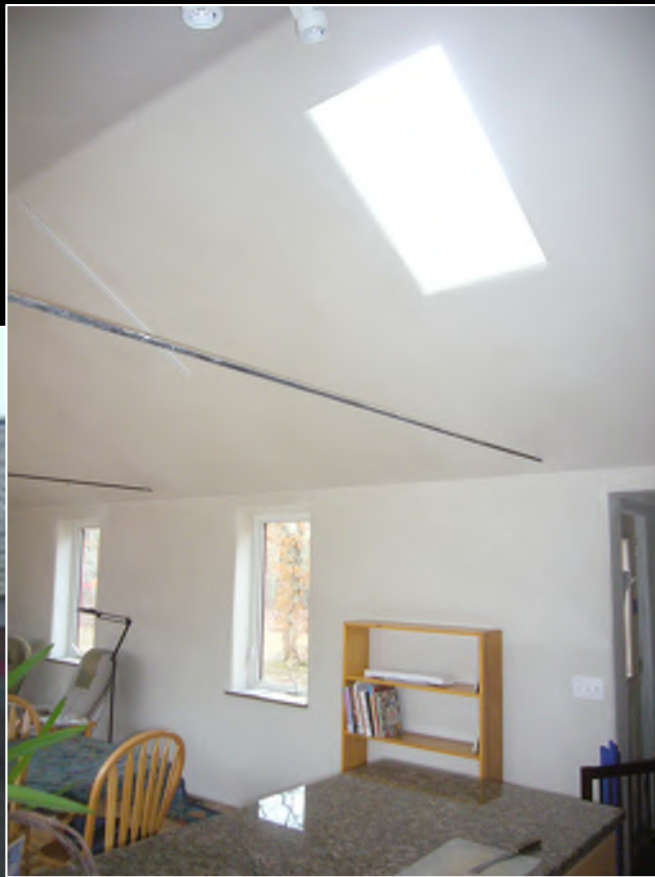
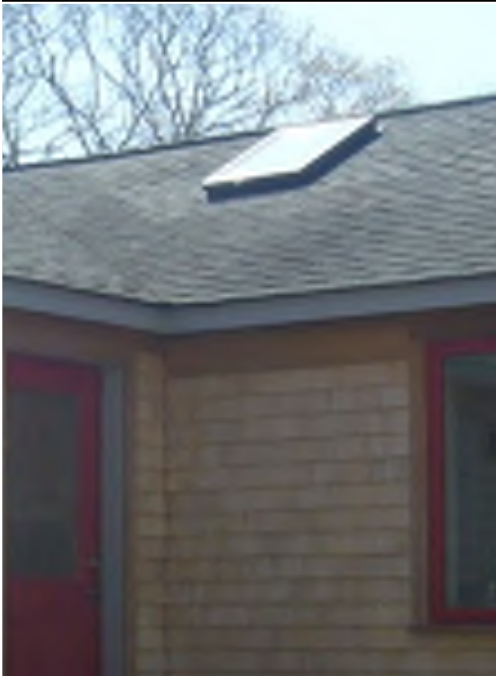
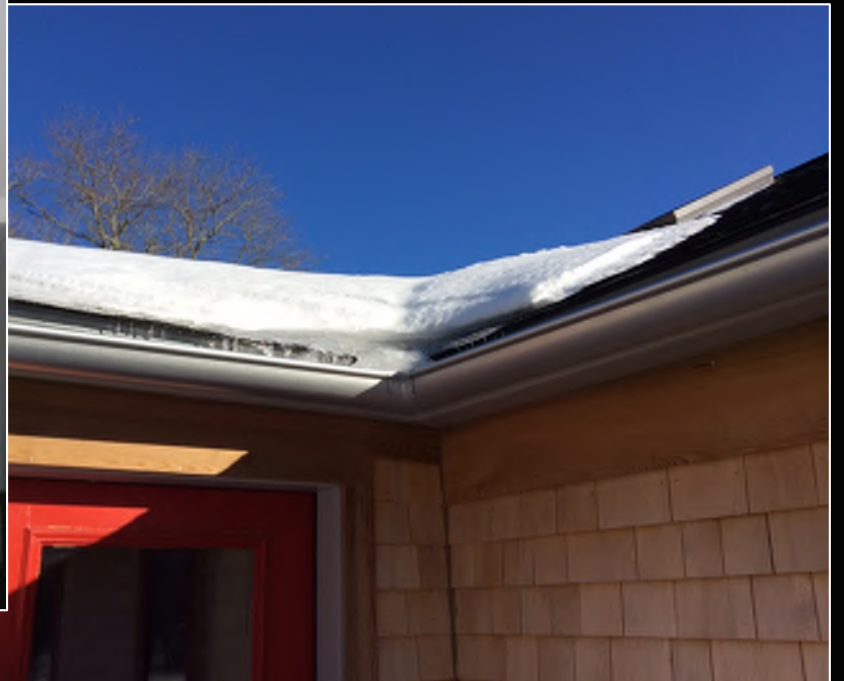
Skylight

- Wasco, PVC frame E series
- Triple glazed, two Cardinal 180 low-e layers (3,5), argon fill
